2015 Myanmar Torrential Rains and Floods

Damage Assessment at Irrawaddy River Banks

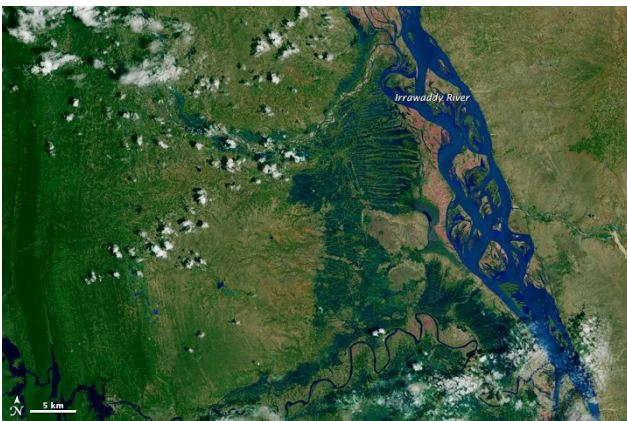
Downstream Irrawaddy River on Aug 29, 2013

The rainfall produced by the monsoon and cyclone flowed into the Irrawaddy River caused widespread flooding and landslides downstream. NASA satellite images show much land is underwater in August 2015 as compared to August 2013.

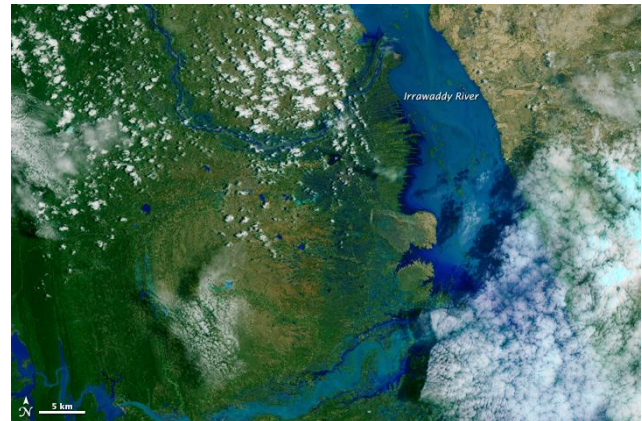
Downstream Irrawaddy River on Aug 3, 2015

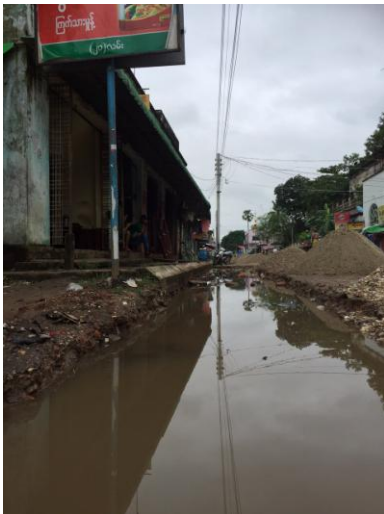
In order to assess the damage, Weathernews staff visited the coastal area of the Irrawaddy River near Nyaungdon, which is situated three hours northwest by car and boat from the city of Yangon. Most of the water has receded, but there are some places still inundated, and littered with driftwood. Full recovery of the area and daily life is expected to take a long time.

Some areas are still under water

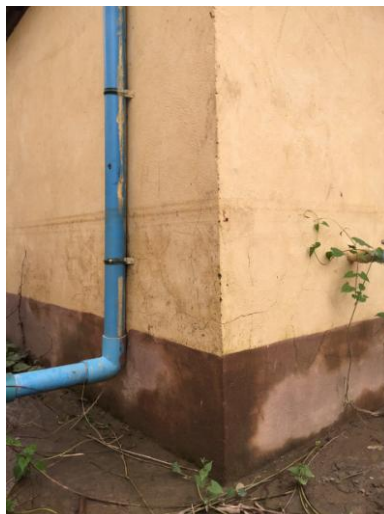
Watermarks on outer walls of houses shows the water reached up to one meter. Land collapses in some areas show widespread dangerous situations. A coastal elementary school also collapsed. Children are taking classes in a temporary classroom in an unaffected building nearby.

Water marks up to 1m above ground

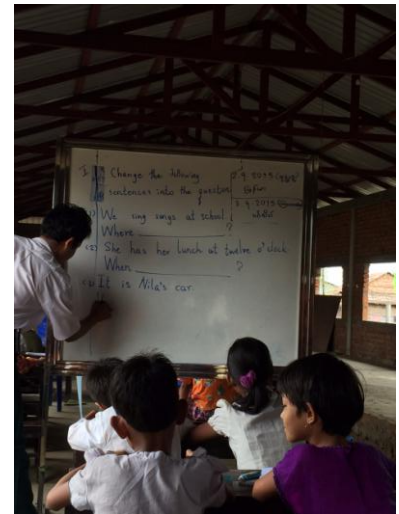
Temporary classroom for a collapsed school

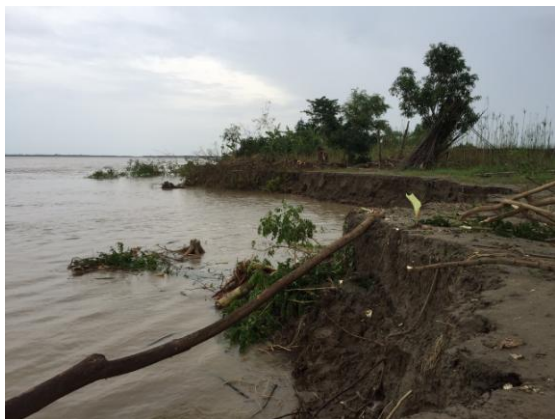
Land has collapsed in some areas

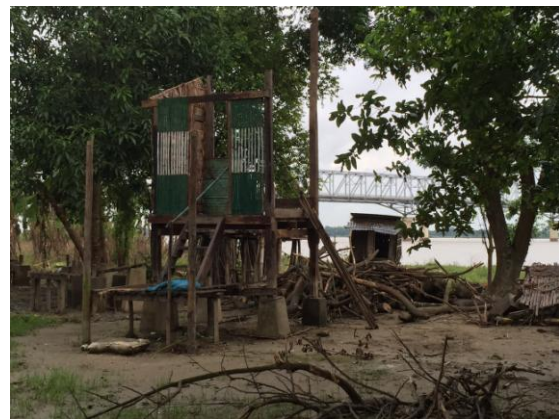
Driftwood from upstream and a damaged building

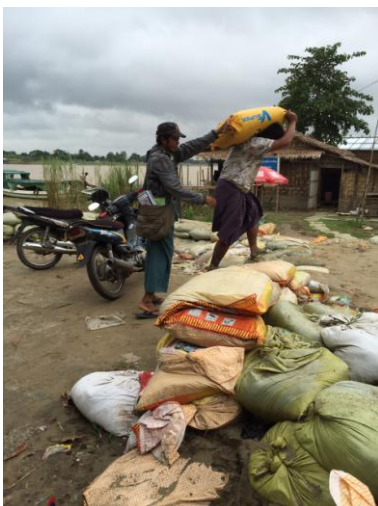
Sandbags are prominent in many areas

As of August 27th, the Irrawaddy River water levels are slowly decreasing, but they are still high and needs careful monitoring based on weather. To minimize further impacts, sandbags are placed around the area.

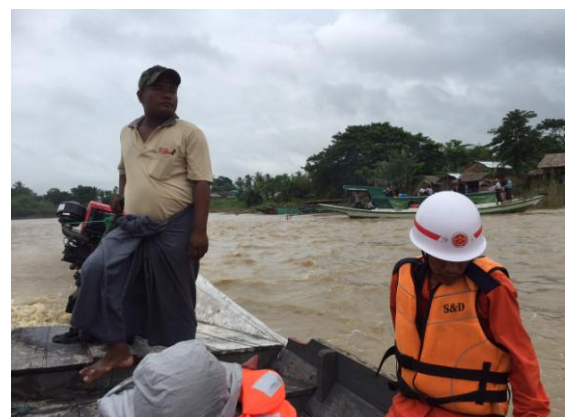
Water level is high and the flow is fast on the Irrawaddy River
