Weathernews works toward practical implementation of Japan's first AI Road Management Support System using video analysis

Conducting operational tests this winter on automatic detection of icy roads / snow cover from dashboard camera images

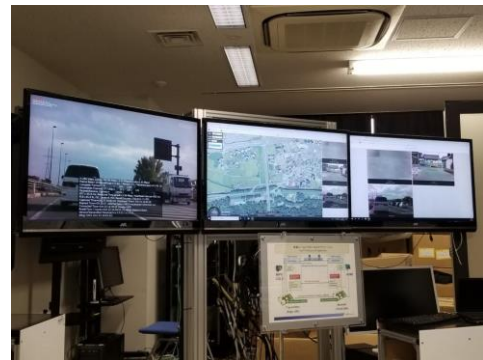
In order to confirm the usefulness of this Road Management Support System for detecting road damage, Weathernews conducted operational testing on October 22nd-23rd with the cooperation of Morioka City. We transmitted, in near-real time, the images from a dashboard camera installed in a vehicle driving around Morioka, and we could confirm the detection of road damage when we analyzed the images using our proprietary technology. Through receiving cooperation from NICT, etc. regarding transmission technology, the real-time transmission of high-resolution images has become possible.

Road surface damage (cracks and potholes) occurs by the following mechanism: Asphalt contracts when it hardens, forming small gaps into which water enters. This water expands when it freezes, causing the road surface to swell upwards (called “frost heaving”). Last year, Morioka experienced record levels of cold and snowfall, and when the spring thaw arrived, visual checks by Morioka city officials and citizens discovered approximately 4,800 cases of road surface damage. According to Morioka City, the number of punctures reported was 10 times higher than an average year (about 200 cases). By conducting automatic detection instead of visual checks, it is likely that earlier discovery of damaged roads would lead to a reduction in the number of punctures and accidents.
